ENHANCED VAPOR RECOVERY

Minimizing Wintertime In-Station Diagnostic System Overpressure Alarms

Informational Bulletin

December 4, 2017

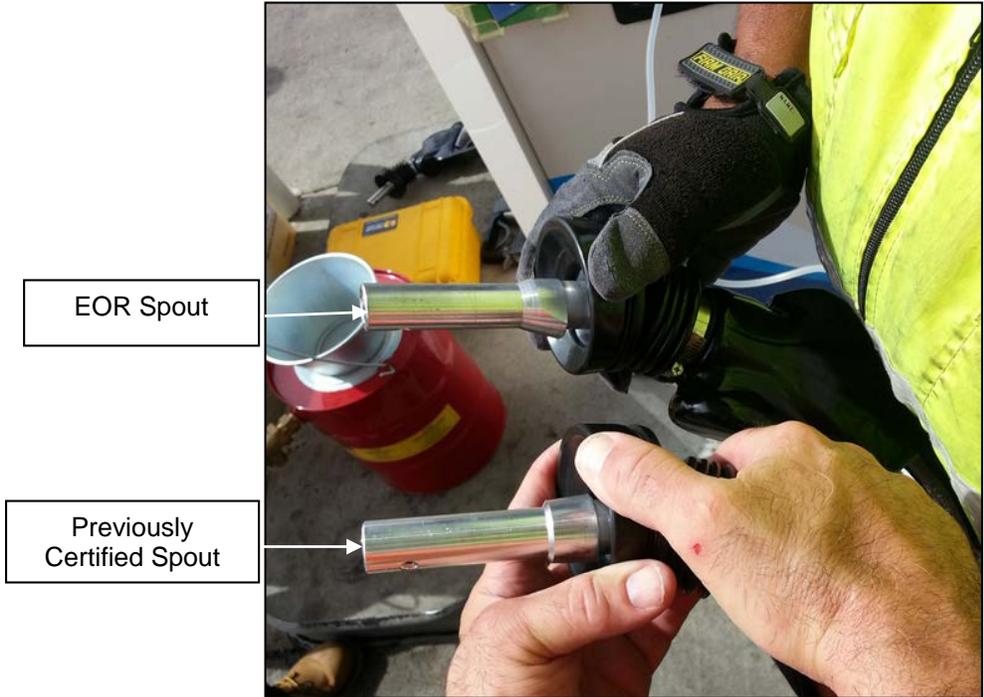
Figure 1: EOR and Previously Certified Spout Assembly (horizontal view)

In response to these findings in 2015, Franklin Fueling Systems (FFS), manufacturer of the assist system, made design enhancements to the spout assembly of the assist nozzle. These improvements enable a better seal between the nozzle's vapor collection boot and the vehicle fill pipe, thereby reducing excess air ingestion. The new spout assembly, referred to as Enhanced ORVR-Vehicle Recognition (EOR), is depicted in Figures 1 and 2 and can be field retrofitted onto existing nozzle bodies. During the winter of 2016/2017, CARB staff evaluated the performance of the EOR spout assembly at eight GDFs, each with

1. Replace existing assist nozzles with the new (factory assembled) nozzles equipped with the EOR spout assembly according to Section 2 of the CARB Approved Installation, Operation and Maintenance Manual (IOM) for the assist system. The new EOR nozzles are anticipated to be available from FFS in January 2018.
