# **Research into the Development of Biological Methods of Dust Suppression in the Antelope Valley**

## **2006 Final Report**

**Soil Ecology and Restoration Group  
Biology Department  
San Diego State University  
San Diego, CA 92182**

**Prepared For:  
California Air Resources Board  
and California Environmental Protection Agency**

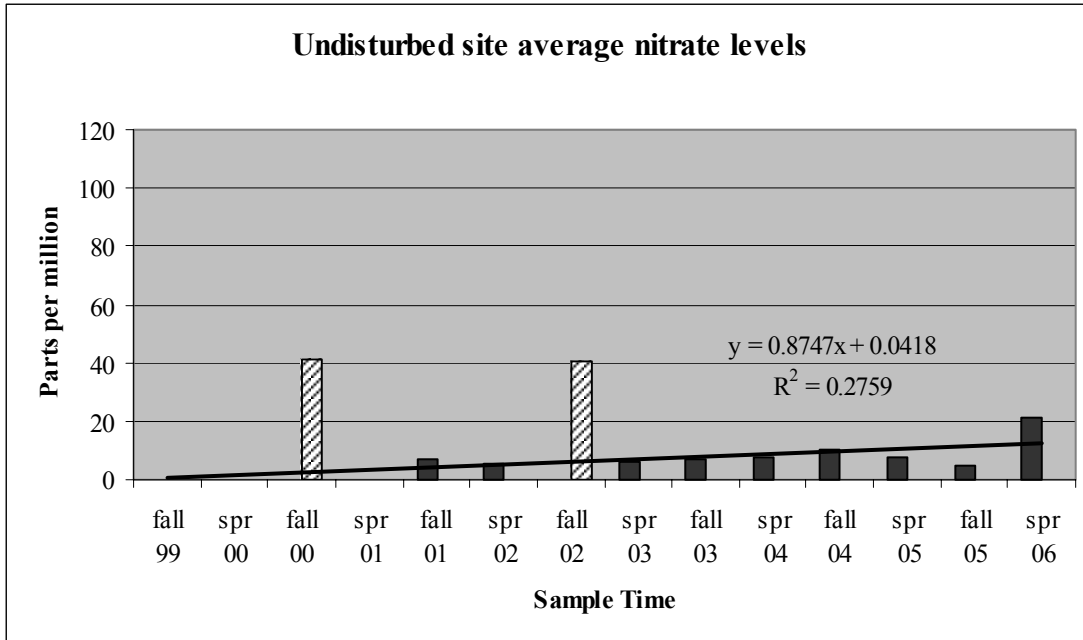
Figure 10. Undisturbed site average nitrate levels of soil samples

The average nitrate levels in the soil at the Undisturbed site were extraneously high for samples taken in fall 2000 and fall 2002. These samples were marked with a diagonal line pattern and were not included in nitrate level observations and calculations for the Undisturbed site (Figure 10). The spring 2006 sample may also have been unexpectedly high, but to a lesser degree than the two samples that were excluded from observations and calculations. The average nitrate levels at the Undisturbed site were low and steady, with a mean value of 8.59 parts per million (ppm). The average nitrate levels at the 90<sup>th</sup> Street site were medium range with a slight decline, with a mean value of 10.20 ppm (Figure 11). The average nitrate levels at the 85<sup>th</sup> Street site declined and were higher than at the Undisturbed and the 90<sup>th</sup> Street site, with a mean value of 63.24 ppm (Figure 12).

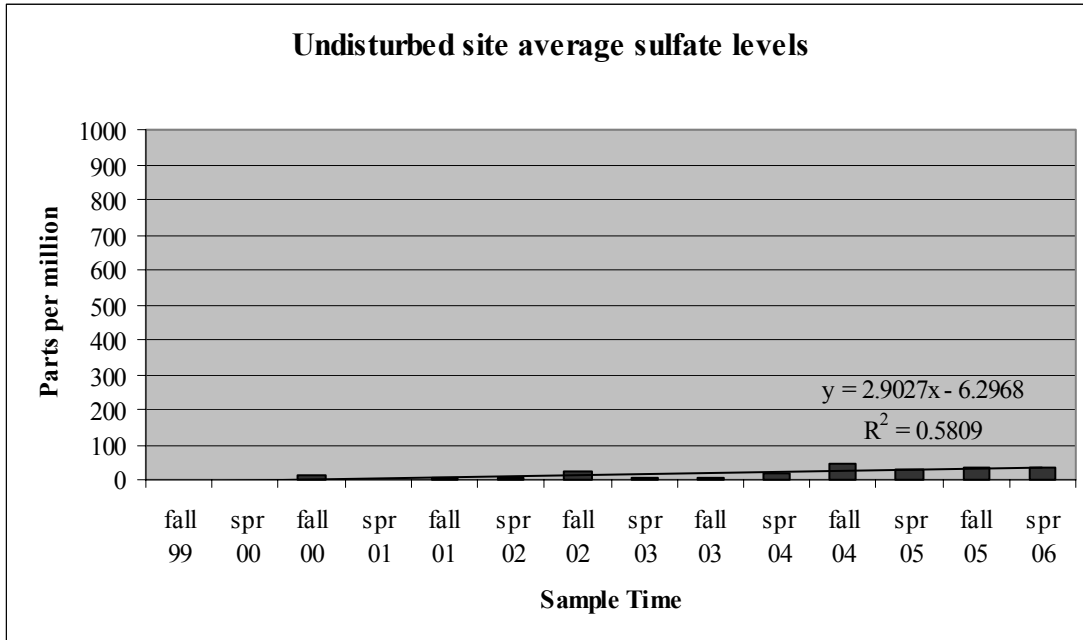
Figure 13. Undisturbed site average sulfate levels of soil samples

The average sulfate levels in the soil at the Undisturbed site made an overall increase, but remained low with a mean value of 19.56 ppm (Figure 13). The average sulfate levels at the 90<sup>th</sup> Street site also made an overall increase, with a similarly low mean value of 11.10 ppm (Figure 14). The average sulfate level at the 85<sup>th</sup> Street site was extraneously high for a sample taken in spring 2002. This sample was marked with a diagonal line pattern and was not included in sulfate level observations and calculations for the 85<sup>th</sup> Street site (Figure 15). The average sulfate levels at the 85<sup>th</sup> Street site declined and were higher than at the Undisturbed and the 90<sup>th</sup> Street site, with a mean value of 354.26 ppm.
