Heavy-Duty Diesel Particulate Trap Demonstration
For: State of California - Air Resources Board

Final Report No. 5761
E14-92-21
Contractors I.D. No. 98-6001250

K. Ha
A. Horton
M. Sumar
Transportation Systems

December 24, 1992.

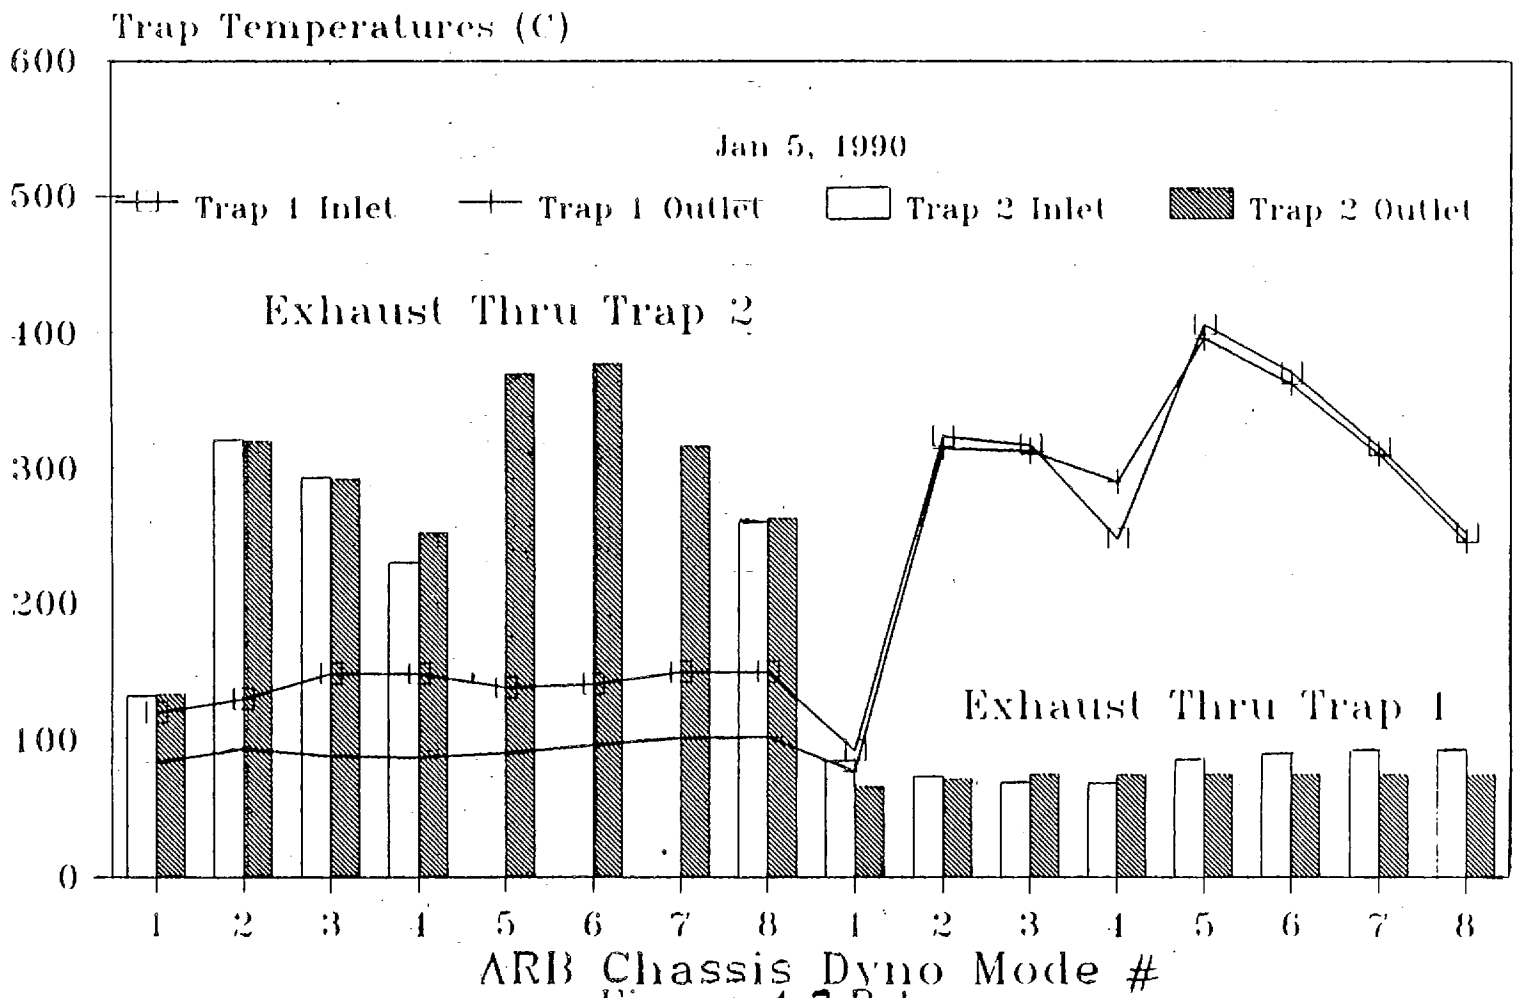
Figure 4.3.2.1

Bus #8924 was emissions tested on January 5, 1990 on the chassis dynamometer and trap performance data was collected (Appendices K and L). The results (Figure 4.3.2.1) suggested exhaust valve leakage.

Appendix M contains regeneration data collected after the suspect valve was replaced. The graphs show the trap temperature profiles (Deg.C) for Trap 1 and Trap 2 and the engine backpressure (in Hg). The face temperatures reached 720°C, which was more than sufficient to start regeneration. The face temperatures showed that the new valve had acceptable leakage during regeneration. Regeneration profiles were satisfactory, showing that the trap system was operating as designed. Bus #8924 resumed revenue service.

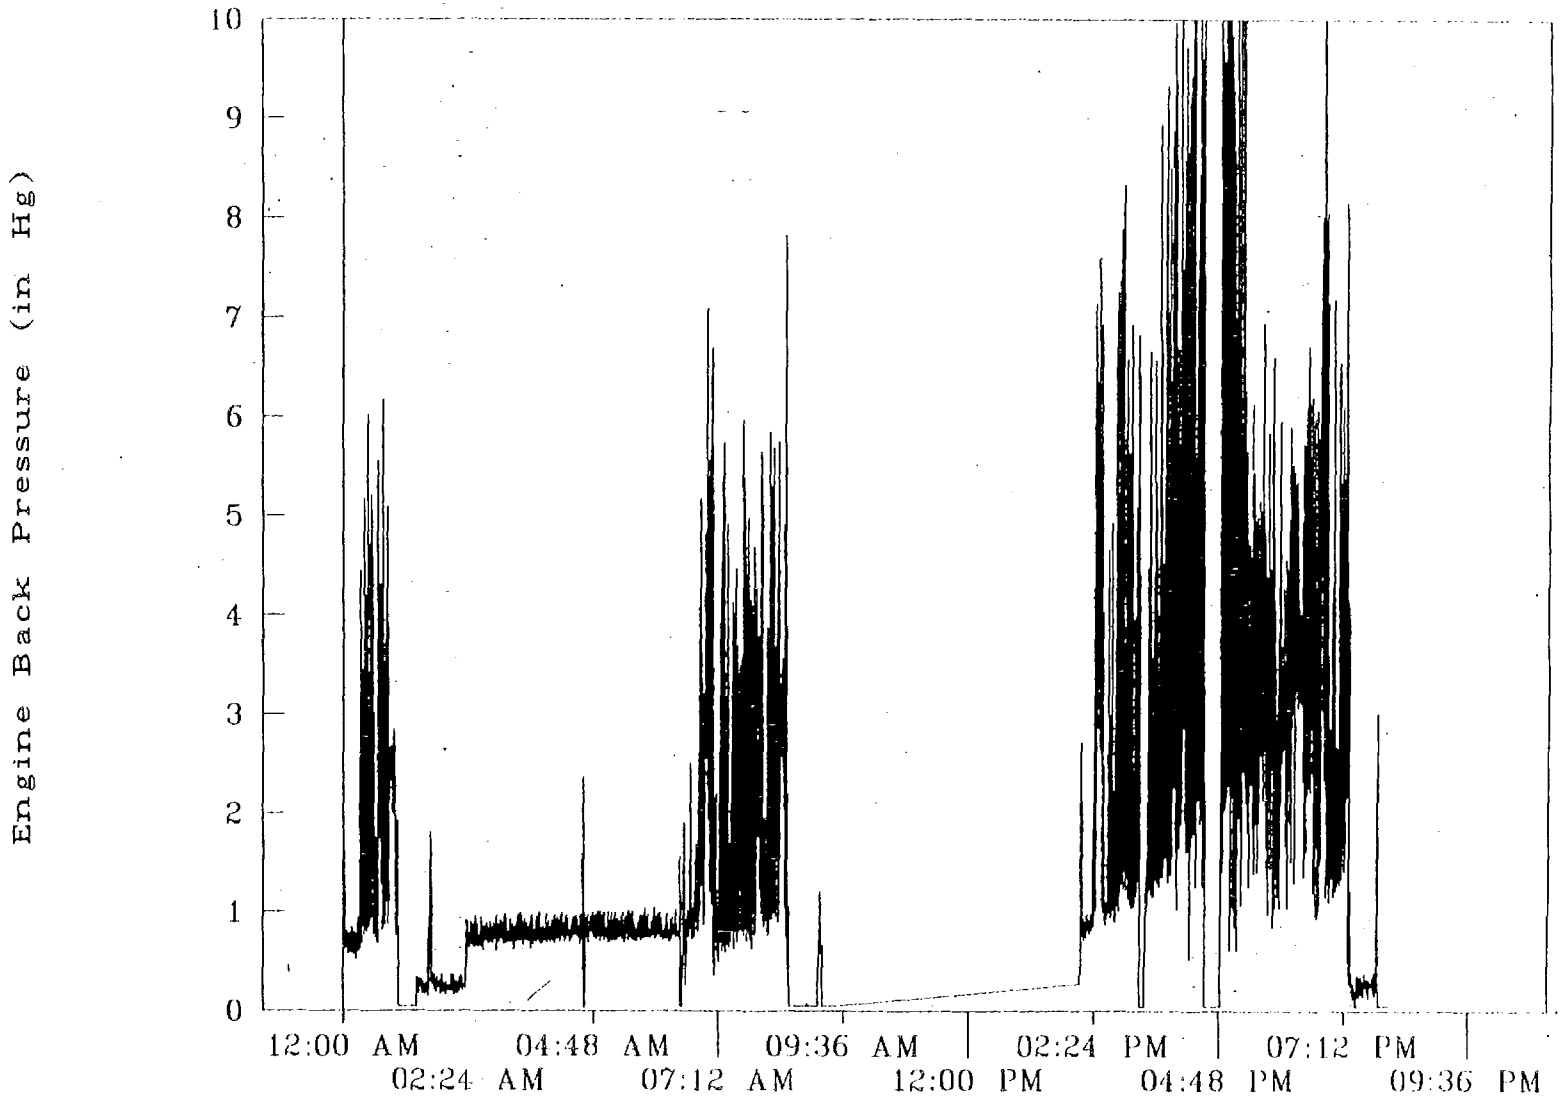
Figure 4.3.4.18

On October 3, 1991, Bus #8924 experienced a trap failure. The analyzed data showed that on October 3, 1991, Trap 1 experienced high inlet and outlet temperature of over 1400°C (see Table 43.4.1). The maximum backpressure exceeded over 11" Hg indicating high particulate loading just before regeneration. Upon examination of the trap, it was found that the inlet and outlet thermocouples for Trap 1 had failed.

The analyzed data also showed that the bus had been been left idling for a long period. The trap control system is not equipped to calculate the K values during idling due to the measurement range of the air flow sensor. This prolonged idling of approximately 5 hours caused the trap to be overloaded with particulates which resulted in the failure of the trap during regeneration.

The excessive particulate loading caused a high regeneration temperature which either cracked and/or melted Trap 1. The data showed that Trap 2 regenerated immediately after Trap 1 had regenerated. The trap regeneration data for Trap 2 showed that the trap temperature did not reach critical value and, therefore, was not damaged. Two additional traps were procured and were installed on Bus #8924 to continue the bus demonstration program.

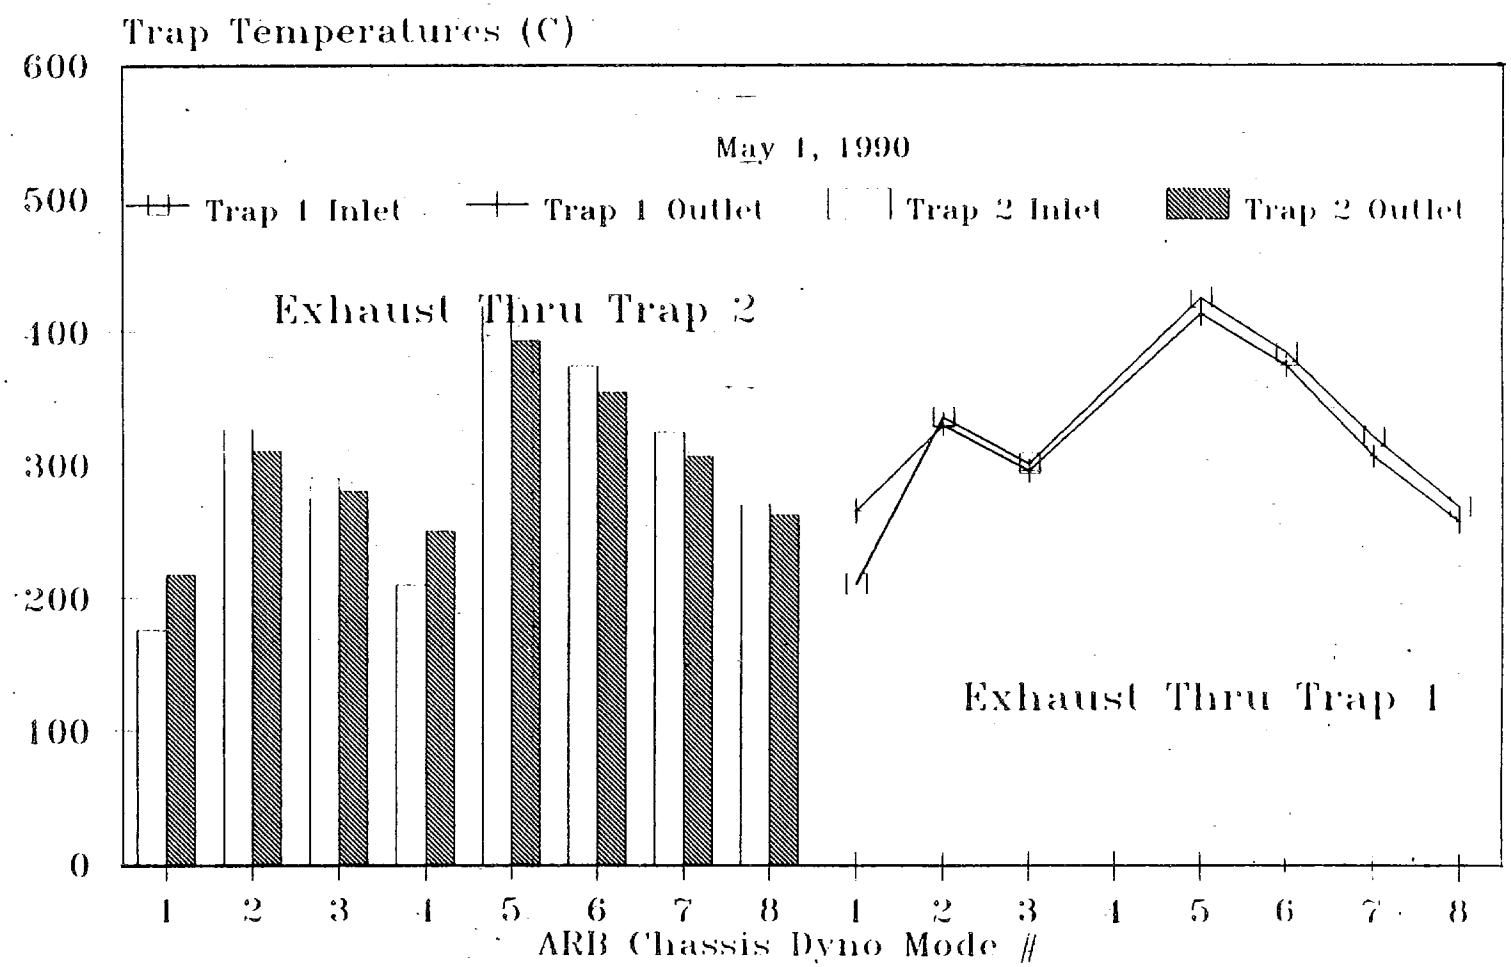
Figure 4.3.5.1 shows the exhaust temperatures during the emission testing. The data was not complete due to thermocouple failures. Available data showed consistent exhaust temperature data and no leakage from either exhaust diverter valve.
