REBUILD CALIFORNIA AIR RESOURCES BOARD  
FIELD FUMIGATION FACILITY AND MAINTAIN  
FOR EXPERIMENTAL USE

Final Report, February 18 - December 31, 1981  
CAL ARB A0-100-32 (Thompson)

C. Ray Thompson  
Principal Investigator

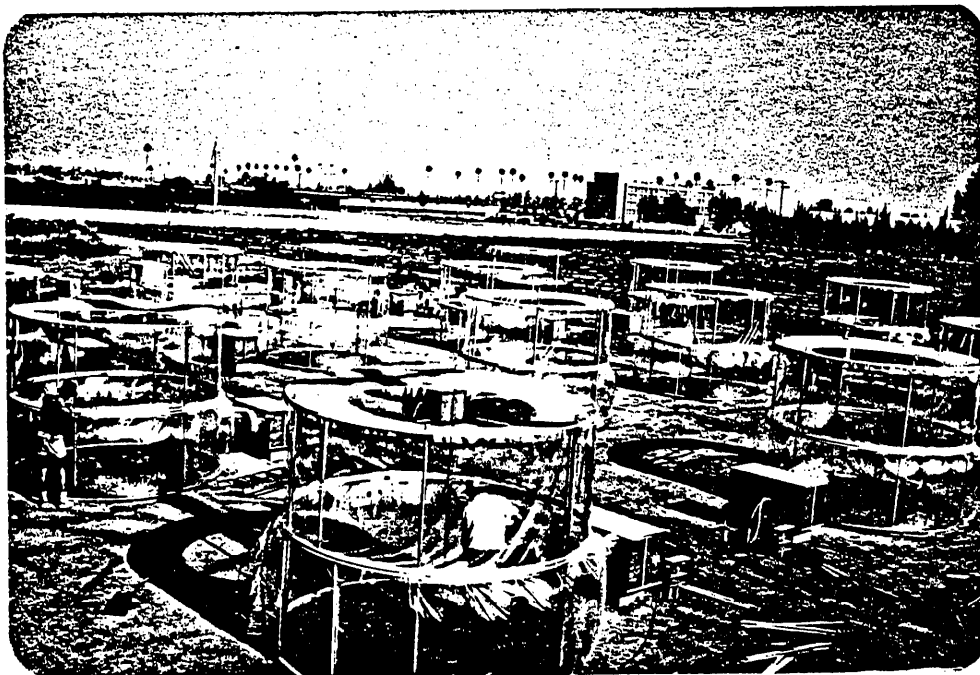
Figure 1. ARB Fumigation Facility at University of California, Riverside, being completed. Note blower housings and activated charcoal filters at right of greenhouse in immediate foreground. All sampling and power lines are installed underground.

During the second quarter the greenhouse frames were completed. Plastic sides, doors for access and septum-like tops were constructed and installed on the frames. Blower boxes were constructed, two activated carbon filters were sealed into the framing with foamed neoprene gasketing and the fans were installed. Blower boxes were positioned and attached to existing electrical controls, see photo, Figure 1.
